NWC TP 5921

Reduction of Fuel Fire Cook-Off Hazard of Rocket Motors

by
Ronald F. Vetter
Propulsion Development Department

JUNE 1977

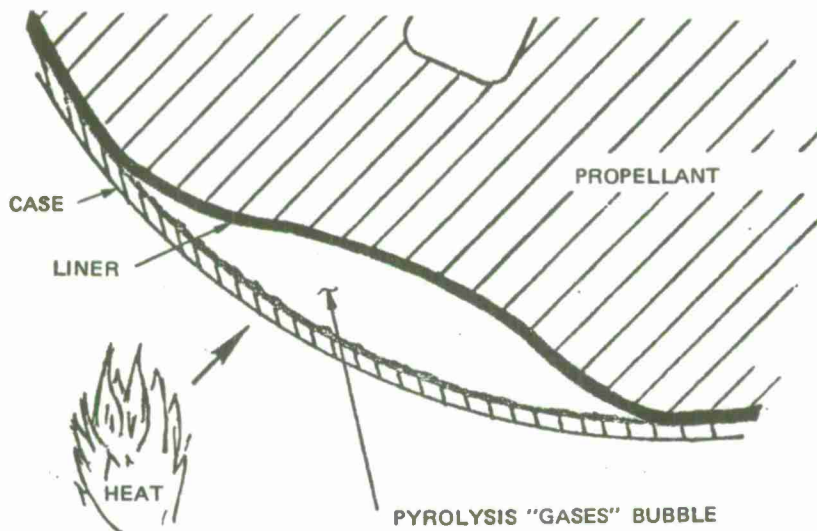
FIGURE 2. Cross Section of Case After Pyrolysis Gases Have Been Generated From the Case Primer and a Part of the Liner. Note that the pyrolysis gases bubble forms on the bottom part of the case in a fire and that clean separation is typical of liner which does not form an adhesive char. The hotter surface of the liner will be liquidus (melting) and a boiling heat transfer exists for a time on the inner wall of the case into the bubble.

faster when the gas bubble(s) exists. The gas temperature also rises, and the pressure rises, dependent upon deformations (e.g., grain perforation compresses) which increase the bubble volume. These pressurized bubbles put a strain on the bondline (where still intact), grain, insulation, and liner materials and load the case wall. Undesirable violent pressure rupture could result from high rate gas generation.

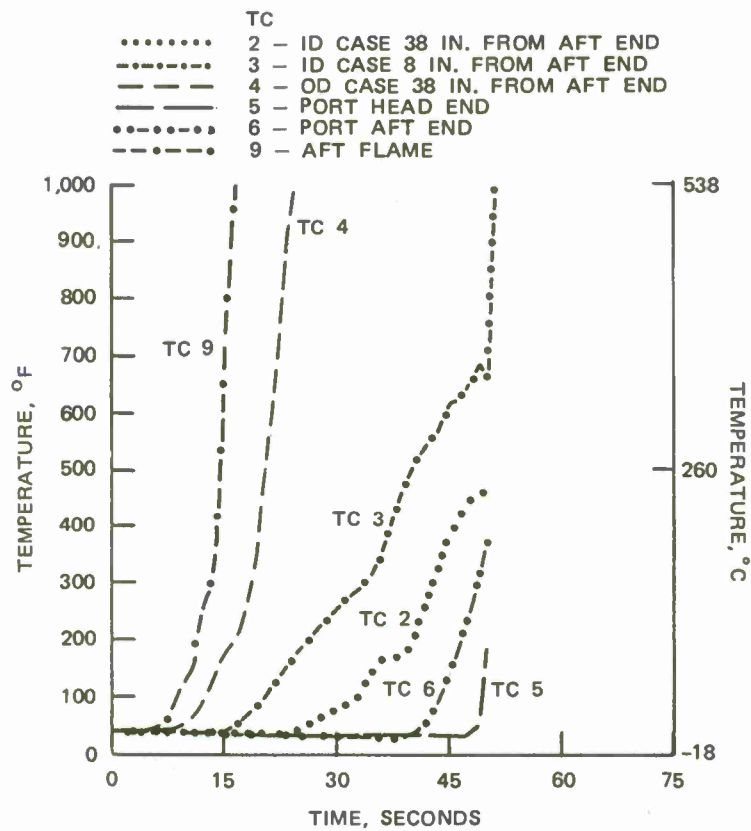
FIGURE 5. Mk 36/50 With Polyether Urethane Liner.

Reloaded Mk 36 hardware, containing an ~ 1.3 mm thick polyether polyurethane based liner (SD-723 plus 2% Kynol fibers and 10% TiO_2), was cooked on 2 April 1975. Results were much worse than anticipated. At 50 seconds there was a violent pressure rupture of the entire case with many small pieces of flaming propellant visible in the movie. Approximately 20 fragments (Figure 4) were scattered about the enclosure and judged to have been hot but not much weakened. (This was based on the approximately 45-degree-angle of the breaks, the folded and wrinkled shapes, and ID thermocouple readings of approximately 240 and 360°C (460 and 680°F). Also, the OD thermocouple was exposed to flame and had been up to saturation and back down to approximately 590°C (1100°F) at the time of rupture.) The aft port thermocouple (Figure 5) indicated temperature rise from 39 seconds to 190°C (375°F) at 50 seconds, while the head end port lagged considerably (start-up at 48 seconds and reaching 85°C (185°F) at 50 seconds). This strongly indicates gases entering the port at the aft end and igniting the bore surface. Both thermocouples were saturated ($> 1315^\circ\text{C}$, 2400°F , at 51 seconds) then went negative; which may mean ignition and loss of continuity at rupture. (The previous test motor, which had the same porous propellant and nonstandard aft end configuration, lost the head end port thermocouple before the test but the aft end temperature rise was similar—it rose a bit more rapidly and reached 232°C (450°F) at 129 seconds, 428°C (803°F) at 130 seconds, and was negative (disconnected) at 131 seconds.) The decision not to use standard casting procedures and tooling (due to difficulty with thermocouple wires and not wanting to modify the tooling) apparently resulted in less pyrolysis gas confinement and propellant voids. This is evidenced by the fact that aft end bonding failed; this would not be expected in the normal configuration which has a preformed aft insulation bonded to the matching aft grain face normally formed by the casting tooling. Also, in the normal configuration, this bond is usually reinforced by a compression fit when the nozzle is inserted. The poor propellant physical properties and the extra strong nozzle closure may also have contributed to the high pressure. In summary, the sample was considered inferior but does demonstrate the importance of fore and aft bonding to seal pyrolysis products and keep them from entering the bore.

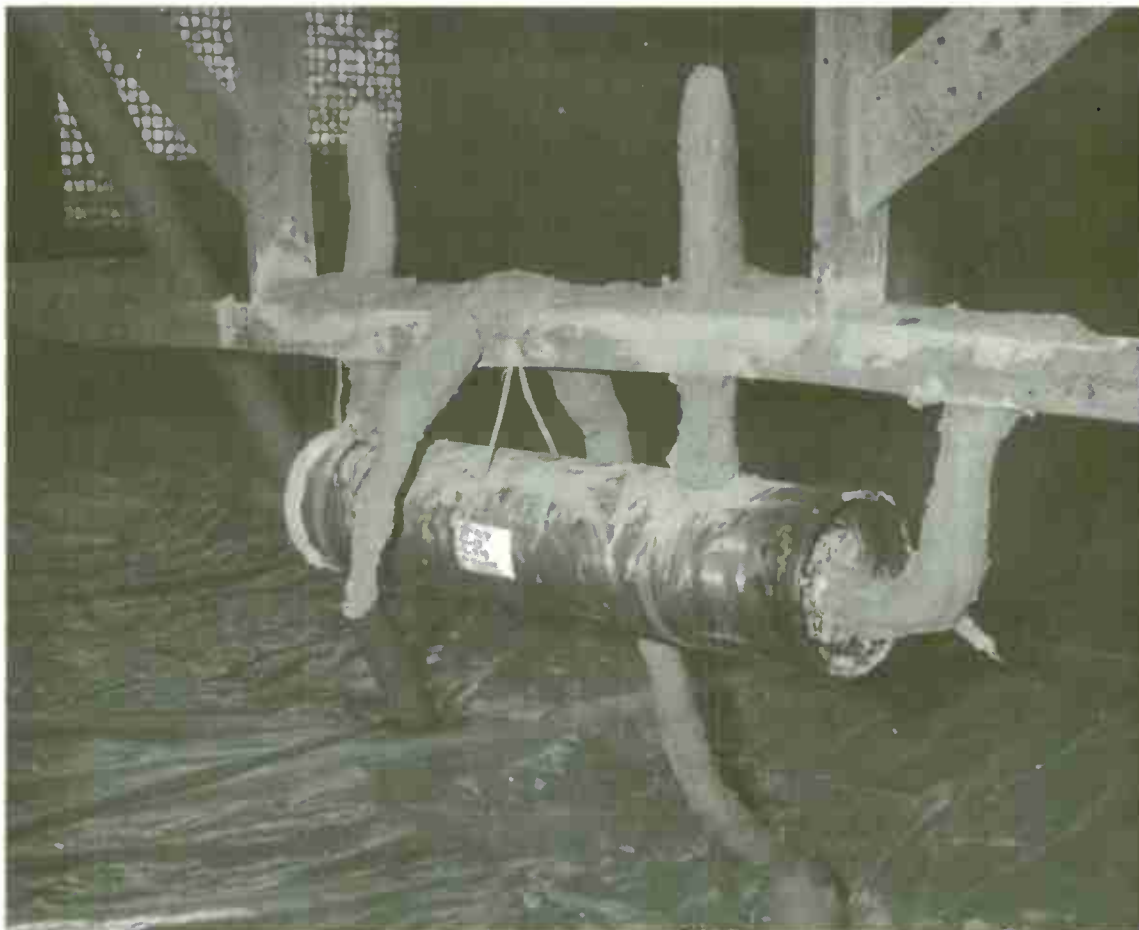
FIGURE 6. Fiberglass Test Item Before Test (LHL 188037).

A filament-wound fiberglass tube with a 0.3 cm wall thickness and 23.5 cm ID (Figure 6) was used as a baseline test motor. This fiberglass tube had six layers of glass wound 75 degrees to the axis and bonded with 31% Dow Chemical Derakane 510-A-40 (fire retardant brominated polyester-styrene) catalyzed with MEKP and cobalt naphthenate as supplied by Owens Corning Fiberglas Corporation.

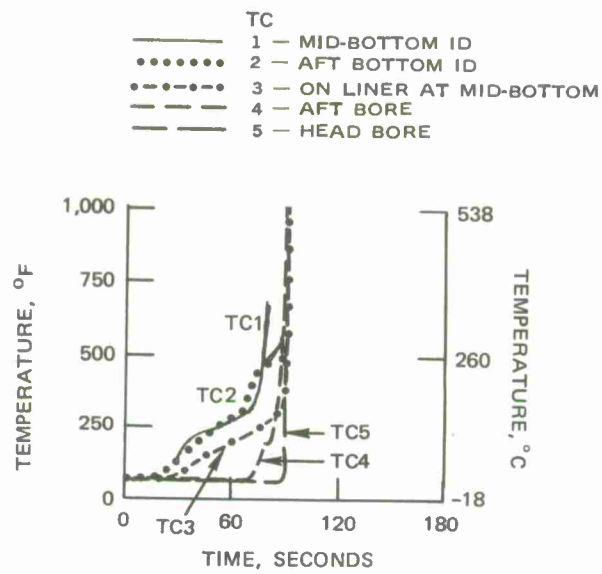
FIGURE 7. Cook-Off of 23.5 cm Diameter Fiberglass Simulated Motor.

The fire was good; all flame thermocouples reached 538°C (1000°F) at 17 to 21 seconds. Thermocouples located on the fiberglass tube ID (midsection and about one-fourth toward the aft end) started rising at 10-12 seconds. They showed a faster temperature rise rate at about 65 seconds and 149°C (300°F). This temperature may correspond to the unbonding of liner and increasing decomposition of the case polymer. Figure 7 shows the temperatures. It appears that the liner/propellant temperature, 155°C (312°F), at 88 seconds (about the time a loud burning noise was first heard) was much below the ignition temperature.

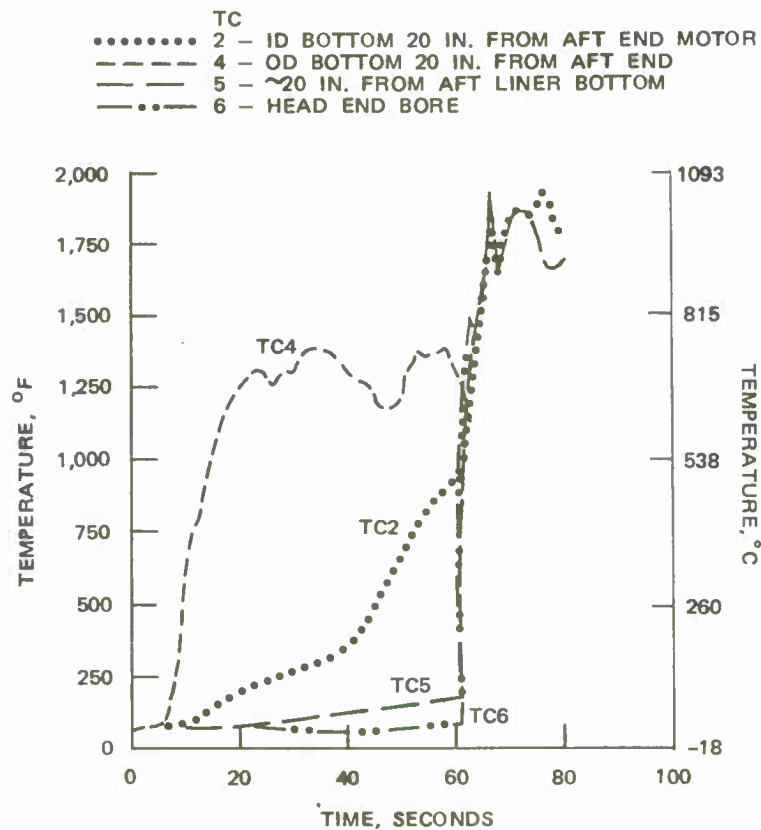
FIGURE 9. Mk 52 (LR-13 Liner/RV-13 Propellant) Temperatures During Cook-Off.

The three thermocouples on the case wall bottom ID showed similar temperatures. All temperatures began to rise at about 9 seconds, reached 400°C (750°F) at about 50 seconds, were near 480°C (900°F) at 60 seconds, and then rose sharply (see Figure 9). All the test-item-connected thermocouples indicated fast rate changes at 62 seconds. Ignition (per sound, television and movies) apparently occurred at 56 seconds; there was a noise (pop) and burning sound at about 58 or 59 seconds with the sound level increasing soon thereafter. Thus, the probability is that the thermocouples were torn loose at approximately 61 seconds. The motor case remains were directly below the original location (Figure 10).

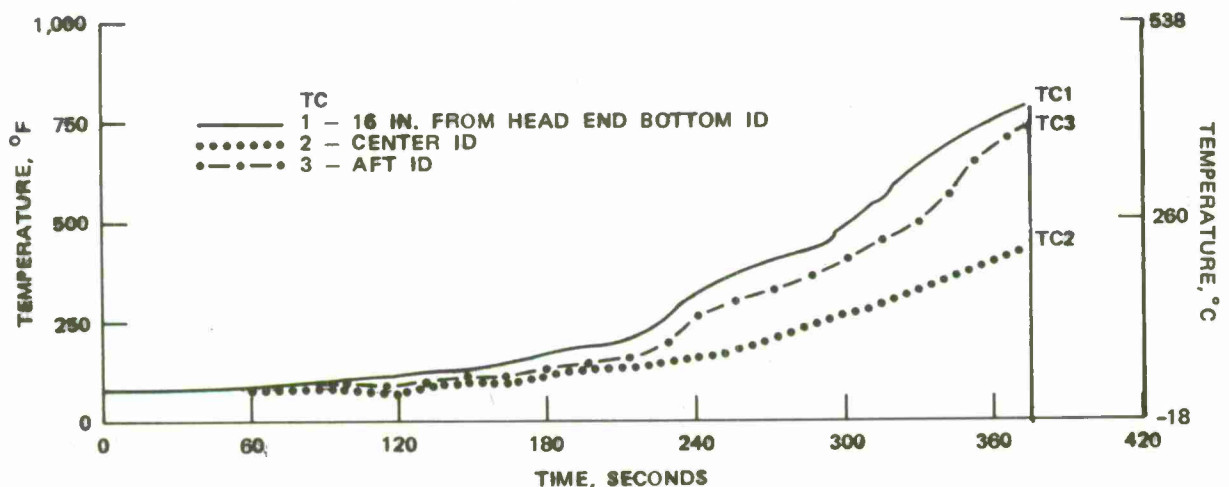
FIGURE 11. Case Inside Diameter Bottom Temperatures During Cook-Off.

Thermocouples were installed on the case ID bottom with one on the liner (liner/propellant interface), one in the fore end, and one in the aft end of the bore. Although high winds were prevalent by test time, it was decided to proceed with the test. The average 9 m/s (20 mph), gusty air resulted in a slow building fire favoring the left side of the item. The flame thermocouple data show slightly more than 538°C (1000°F) after 375 seconds, when bursting reaction occurred. Figure 11 shows the unusual situation of forward and aft motor case ID temperatures being higher than the case center ID. The flame thermocouples (added to measure temperature immediately next to the motor case on each side of the motor midsection) indicated several hundred degrees higher than the head and aft case bottom ID thermocouples. We thus have a wider than usual spread of internal case temperatures, 200 to 400°C (400 to 750°F), at reaction. The primary difference for this fire was its low temperature with, consequently, a much different thermal wave into the motor. More heat energy penetrated further into the grain and reaction rates were lower than for a "normal" fire. Also, the case strength was higher at the lower steel temperature.

Deflagration (pressure rupture) occurred at 375 seconds. The fire never reached the MIL-STD-1648 requirement since the highest peak of flame temperature was only 650°C (1200°F) per the thermocouples near the item. The case tears were full metal thickness (not stretched skin) and yielded fifteen pieces with little remaining of the head or aft domes (see Figure 12). One large chunk of propellant left the pit itself and burned near the cage wall. Propellant burned from approximately 380-400 seconds, which indicates relatively large chunks. The single liner/propellant interface thermocouple showed 133°C (272°F) at 375 seconds (Figure 13), but the center bottom was less heated than the fore and aft regions. As is often the case, the aft bore temperature rose fairly rapidly, leading to ignition. This is assumed to be hot pyrolysis product gases leaking around the aft grain end and is believed to be the proximate cause of ignition.

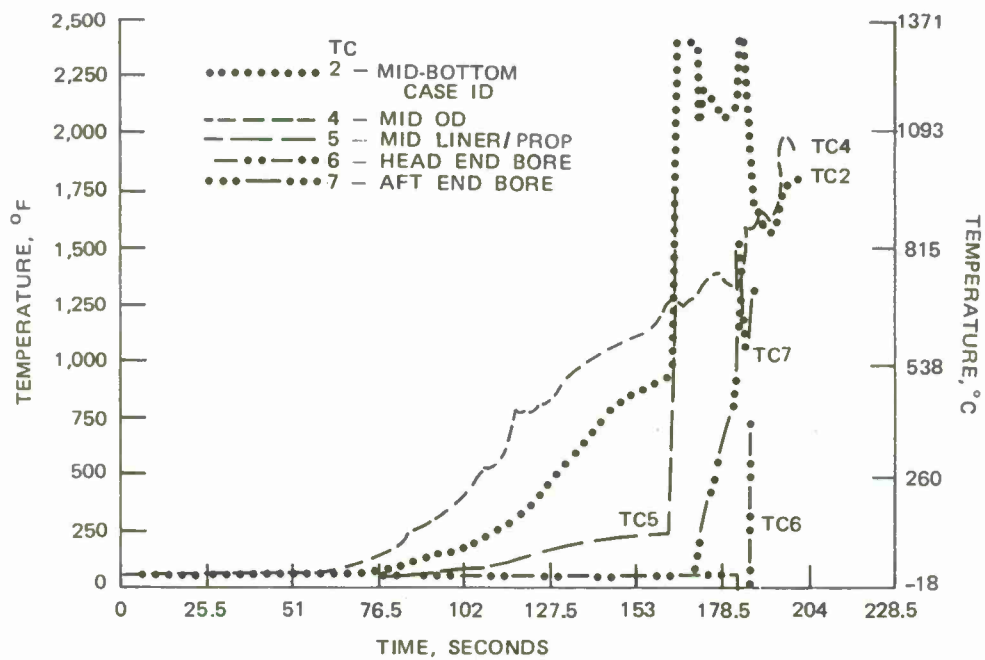
FIGURE 17. Temperatures During Cook-Off of Mk 36/50 With HTPB Liner.

There was a mild breeze when this unit was tested. The unit was exposed to 600 gallons of burning JP-5, but the breeze had only a mild effect. However, a delay (after adding the regular gasoline (starter) to the rags with their squibs) for the purpose of recalibrating the computer led to a slow ignition. A temperature of 538°C (1000°F) was reached at 101-129 seconds and initial ordnance reaction occurred at about 160 seconds when flame temperatures were below 815°C (1500°F). The initial reaction was a low level sound increasing over several seconds to the usual low pressure propellant burning noise at 170 seconds. A visible eruption and increased burning were noted at 184 seconds with burning noise until about 200 seconds. Post-test inspection revealed that the aft end of the motor had burned through (Figure 16), then the nozzle and grain ejected. The ejection pressure was sufficient for the nozzle to make a small dent in the 3 mm witness plate, but the motor tube was propelled much more forcibly by the propellant and the dummy warhead pierced a witness plate, bent its support frame and lifted the plate around (pivoted approximately 90 degrees when hit on one end). Thermocouple data indicate the case ID was near 538°C (1000°F) at first reaction with flame exposure at 164 seconds. The liner/propellant bondline thermocouple also showed a similar response at the same time. This may mean that the initial propellant burning was in the vicinity of these thermocouple leads (considered likely) and not all along the tube ID bottom. The aft bore temperature started rising at 170 seconds (when burning noise was established) and jumped at 183 seconds while the head end bore temperature showed an increase of 17°C (30°F) at 138 seconds and went negative at 184 seconds (Figure 17). This means internal bore ignition from aft end gases and nozzle ejection occurred at 184 seconds.

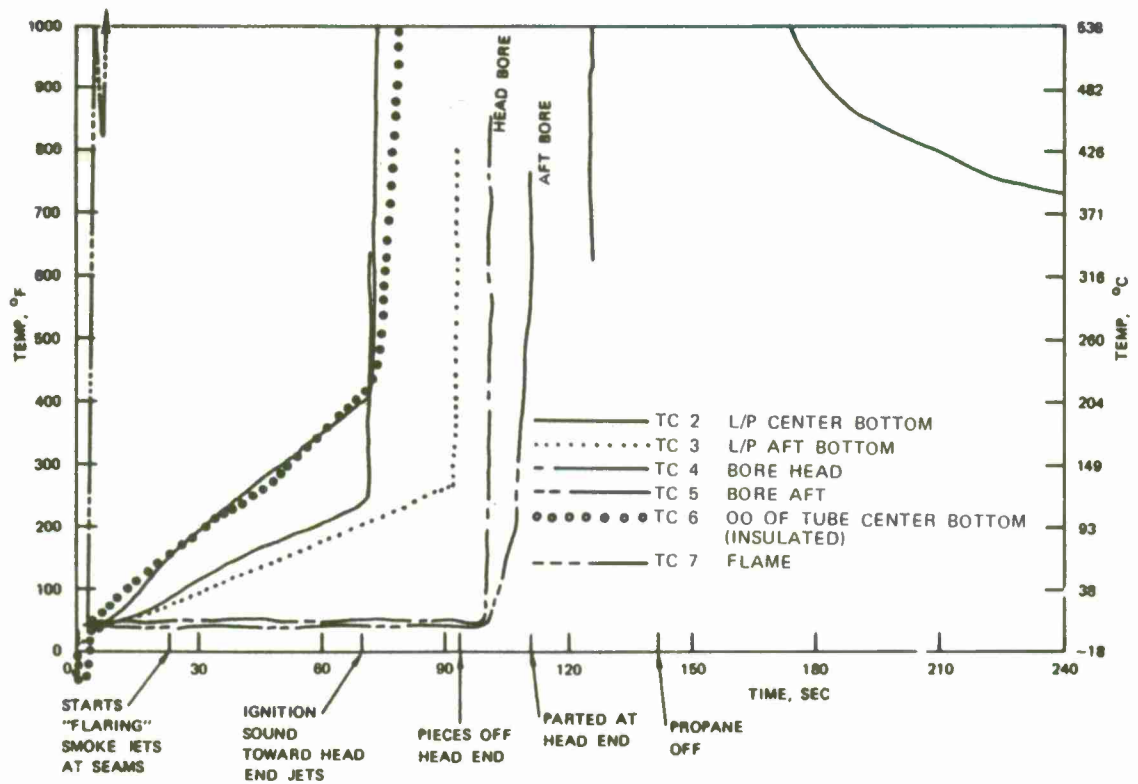
FIGURE 20. Temperatures During Cook-Off of HTPB Lined Low Smoke Propellant Loaded Steel Shim Spiral Laminated Rocket Motor.

Test of 0.25 mm by 10-cm-wide spiral wrapped bonded steel shim (Rapier type) 13 cm diameter "motor" resulted in mild deflagration, as expected; i.e., the unit burned in place with low pressure and no pressure vessel burst. Thermocouple data are shown in Figure 20. A high speed movie shows the formation of smoke jets from numerous places as the case adhesive decomposed. Eventually, propellant ignition occurred on the grain outside diameter. This resulted in gas that cut the shimstock and enlarged holes, as well as causing unraveling of the shimstock on [ne end. The bore, reached by burning through the web, was then ignited and the case soon separated from one end closure. Two motor end pieces plus a dozen pieces of unwrapped shimstock were all that remained (see Figure 21). This test, using the unique construction in a closed vessel configuration, indicates that this motor case fabrication method can provide ordnance which will "burn" per MIL-STD-1648(AS) in a fuel fire.

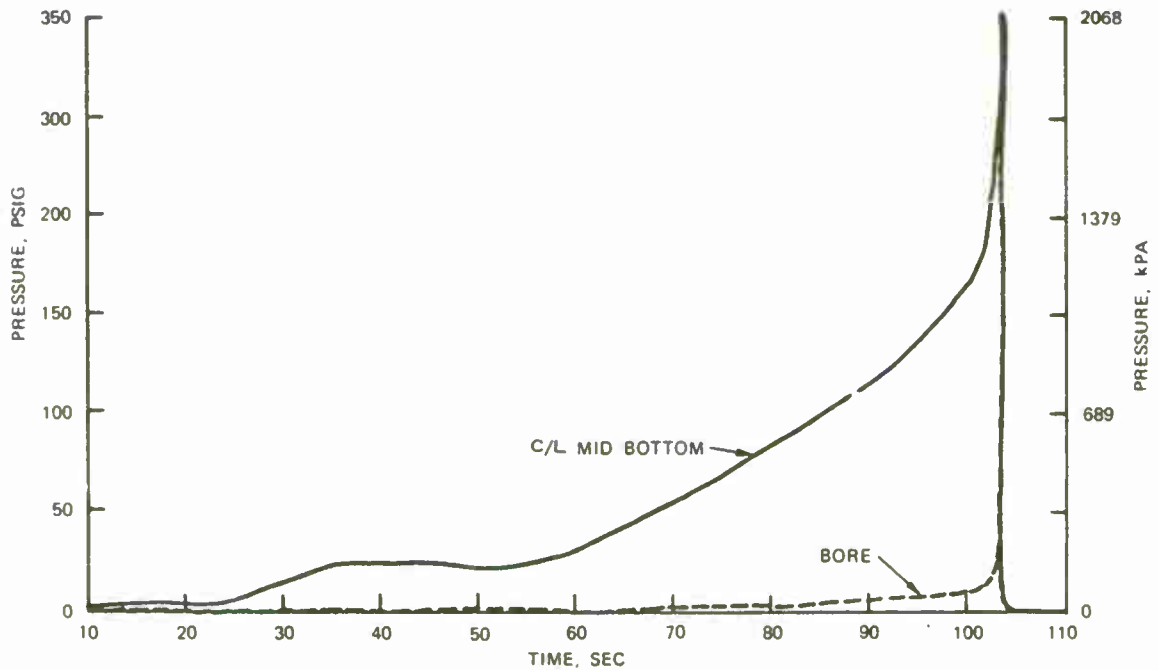
FIGURE 23. Pressures of Bore and Liner/Case Mid-Bottom During Cook-Off.

A 10-cm-diameter model motor, lined with HTPB based liner containing oxamide and cast with low smoke HTPB propellant, was tested in the propane/air burner facility. Figure 22 shows the thermocouple data obtained and Figure 23 shows the bore and liner/case midbottom casewall pressures monitored during the cook-off. The vagaries of the thermocouple readings are believed due to eventual thermal flow to junctions in some of the thermocouples. These junctions were necessary due to severing during lining operations. No movie coverage was obtained because the film broke; however, video tape records were obtained. The failure mode was again structural loss of the flat end of the model motor and ejection of the grain. The oxamide/HTPB liner showed gas pressure at 25 seconds with a maximum thermocouple temperature of 232°C on the case ID. The polyether liner gas pressure rose a bit at 38 seconds when 343°C was seen by one case ID thermocouple. There was much more pressure (more gas formed) from the oxamide filled liner. Case rupture (end plate ejection) occurred at 104 seconds for the oxamide filled liner at 2.1 MPa, per the slow response gauges. (The polyether-polyurethane-lined unit had a maximum pressure of 1.4 MPa and failed at 58 seconds.) Neither case showed steel stretching although the oxamide-HTPB-lined case ID maximum thermocouple temperature was 660°C. Figure 24 is the oscillograph pressure traces at rupture.

It is difficult to do more than conjecture that some propellant surface area ignited at about 101 seconds (see Figure 23) and that the movement of the grain (allowed by failure of the closed end) toward the rupturing end allowed gas to enter the bore. Pressure on the grain OD caused it to deform inward and against the aft (open bore) end taper. Failure of the closed end then would vent the forward end pressure, providing the force to hold the grain against the aft closure. This means that the case failed before the gases leaked into the bore, i.e., the bore was not ignited prior to failure.

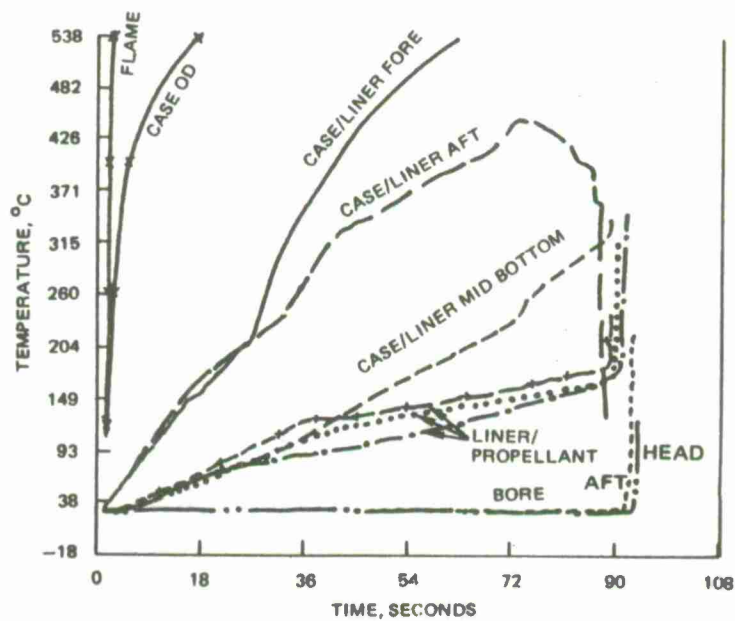
FIGURE 27. Thermocouple Temperatures During Cook-Off With LR-29M Liner and RV-7 Propellant.

The videotape test records indicated loud noise and case separation at the aft joint, etc., at 89 seconds after propane ignition. Thermocouple data (Figure 27) showed some activity at 88.5 seconds or soon thereafter. The bottom ID (fore, center and aft) thermocouples showed a jump at 89 seconds while the liner/propellant temperatures near those same locations increased at 90.5, 91.5 and 89.5 seconds, respectively. Bore thermocouples showed minor rises at 88.5 and 89 seconds; these may have been due to adiabatic compression or electrical signal cross-over. Aft bore temperature rise occurred after 92 seconds, while forward bore temperature rise occurred at 94 seconds. The unit was burning well on the grain OD and separated into two pieces at that time. Unexplained temperature excursions of the case ID thermocouple data occurred after 70 seconds.

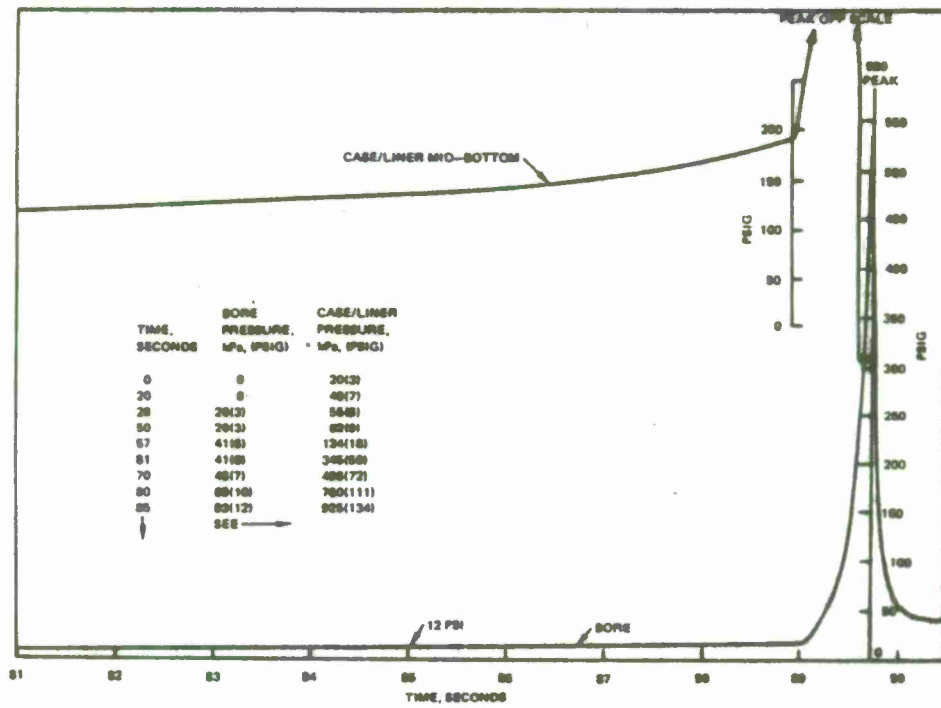
FIGURE 28. Pressures During Cook-Off.

The center bottom case/liner pressure tap and aft end bore pressure measurements provided some interesting data (Figure 28). Case/liner pressure started to rise very quickly, with a little jump from 124 kPa (18 psig) at 57 seconds to 276 kPa (40 psi) at 60 seconds. A knee, where the rate of rise jumps up, occurred at 88.9 seconds with the case/liner pressure at 1324 kPa (192 psig). Bore pressure was first indicated at 28 seconds, then reached 41 kPa (6 psig) at 60 seconds and 138 (20 psig) at 88.9 seconds. Bore pressure then jumped to a peak of 4 MPa (580 psig) at 89.7 seconds after the case/liner pressure peaked off-scale at 89.6 seconds.

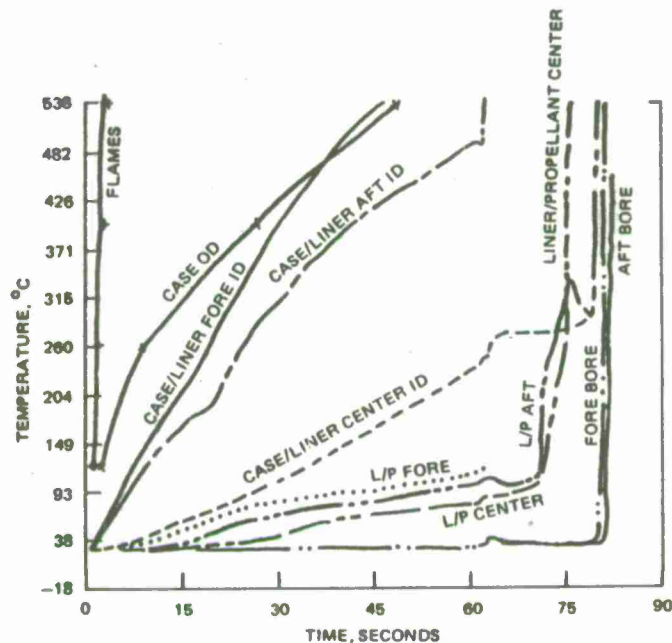
FIGURE 32. Temperatures During Cook-Off of Polyether Polyurethane Lined Model Motor.

Thermocouple data (Figure 32) show the forward bottom case ID, and bottom case OD just forward of center, were both quite hot, reaching 538°C at 45.5 and 48.5 seconds, respectively. The forward ID reached a peak of 598°C at 57.5 seconds, then dropped a few degrees to 580°C at 60.5 seconds. At this time there was a very rapid rise to propellant flame temperature (thermocouple saturation at 62 seconds) which would indicate ignition of some propellant near the thermocouple. The thermocouple on the liner (about 2.5 cm from the case ID thermocouple) showed a jump from 120°C at 62 seconds to 1304°C (saturation) at 62.5 seconds. Recall that the case/liner pressure showed an increasing rate rise from 60 seconds to a peak at almost 62 seconds with case rupture at about 62.5 seconds. The bore thermocouples both jumped about 11°C at 62.5 seconds, which probably indicates some gas was leaking into the bore. The aft rise was actually 14°C while the fore end rise was 9°C. These are probably more than would be expected from adiabatic air compression when the propellant "balloon" is compressed, but perhaps not. The bore did cool until 79.5

seconds, at which time the forward bore thermocouple started to rise. The aft thermocouple started up at 81 seconds and both reached saturation at 82.5 seconds. Bore pressure showed a rise at 80 seconds. The aft bottom liner/propellant thermocouple indicated that flame reached it at 76 seconds while the center bottom liner/propellant thermocouple was saturated at 81 seconds.

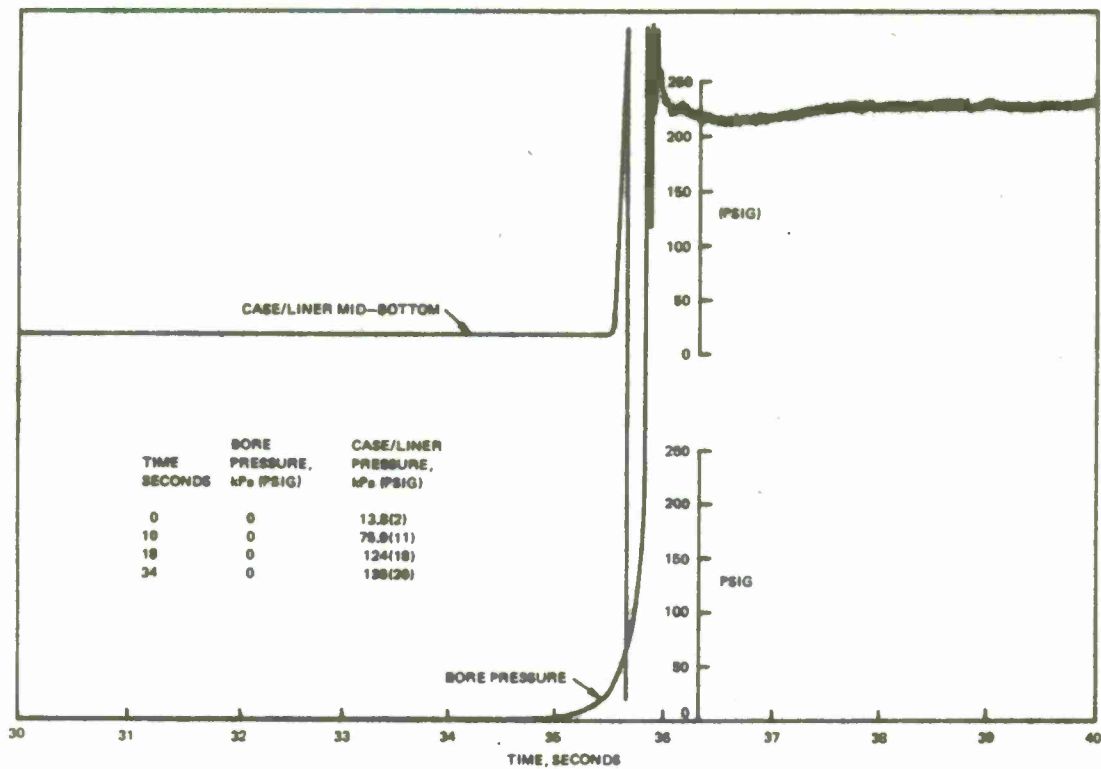
FIGURE 33. Pressures at Case Rupture.

Midbottom case/liner and bore pressure data were taken as before (Figure 33). The case/liner pressure data do not appear to be accurate; pressure rose very quickly but then stayed flat at about 131 kPa (19 psi) from 18 to about 36 seconds when an abrupt rise (off-scale) above 2.1 MPa (300 psi) occurred. The bore pressure showed no pressure rise until 35 seconds, then rose relatively slowly to 138 kPa (20 psi) at a faster rate (from the time case/liner pressure spiked upward) to about 483 kPa (70 psig), then faster yet until saturation and gauge failure 0.1 second or more after the case/liner pressure spiked.

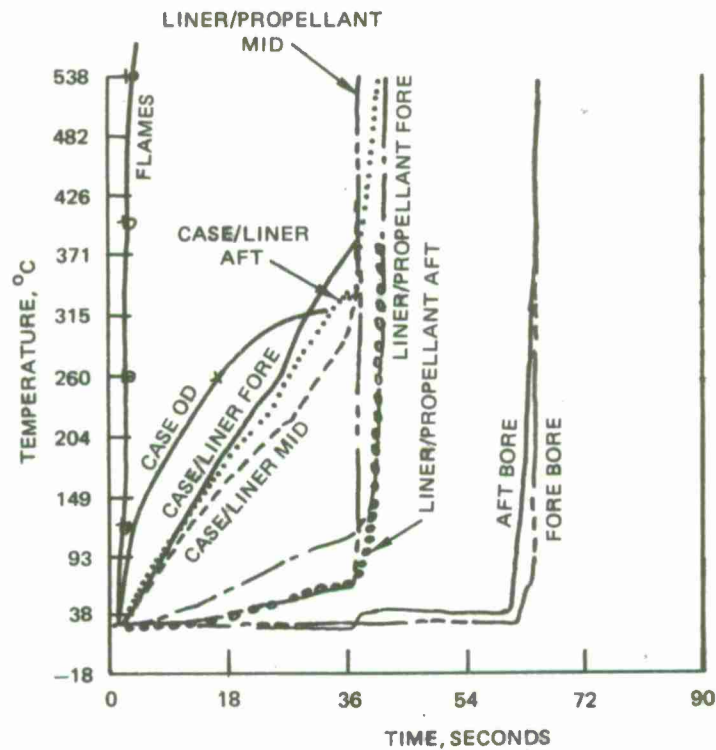
FIGURE 34. Temperatures During Cook-Off of HMX Propellant Model Motor.

Thermocouple data (Figure 34) show case ID bottom temperatures of 315-370°C at rupture. One thermocouple shows a decrease for 1 second before 37.5 seconds, which apparently was the rupture time. The data at the 38 second time show jumps and discontinuities although two thermocouples jumped at the 37.5 second datum. Thermocouple saturation (equivalent to propellant burning about the thermocouple) was first reached at 40.5 seconds on the two thermocouples that had been attached to the case ID. Of the three propellant/liner thermocouples, one reached saturation at 42.5 seconds and the other two reached saturation at 44.5 seconds. This agrees with the movie observations of no propellant burning for a brief time after case rupture and gradual ignition of the propellant as the liner burned away. The bore thermocouples showed an 11°C jump at 38 seconds for the aft end only and rose at

61.5 and 62.5 seconds for the aft and fore ends, respectively. The head end showed flame temperature at 65 seconds, followed by the aft end at 69.5 seconds. These times correspond to the grain bending nearly 90 degrees, as was seen in the movie and video films, and then burning from both ends.

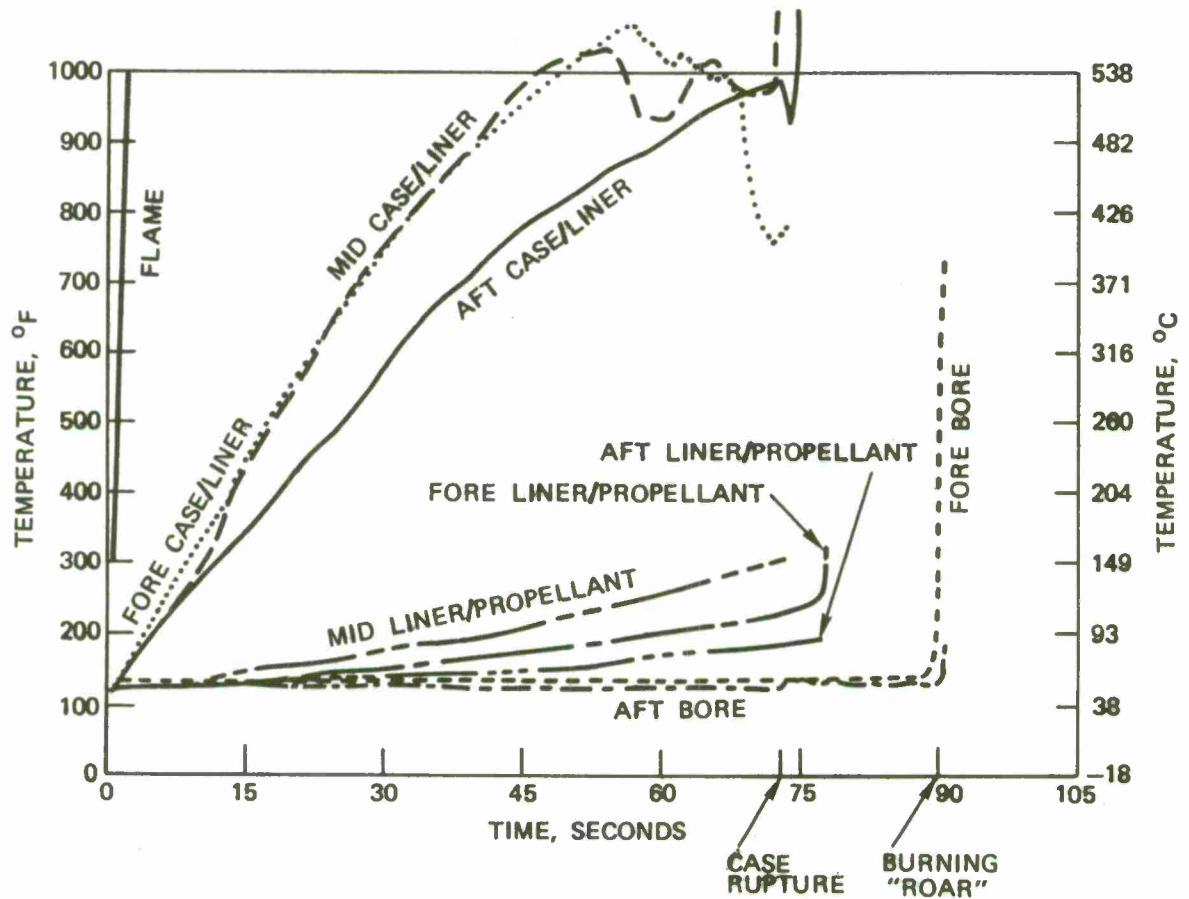
FIGURE 36. Temperatures During Cook-Off of SD-723/LR-29/RV-7 Model Motor Test.

The thermocouple data for this test (Figure 36) show internal case wall temperatures above 538°C (1000°F) with some cooling before rupture. The cooling may have been due to material movement and pyrolysis gases flowing. The highest temperature of three liner/propellant locations at time of reaction was 149°C (300°F). Some disturbance of bore temperature occurred at reaction, but burning of the bore did not initiate until 88 seconds (15 seconds after case rupture). The video and movie coverage verify the web burning through from the OD at that time:

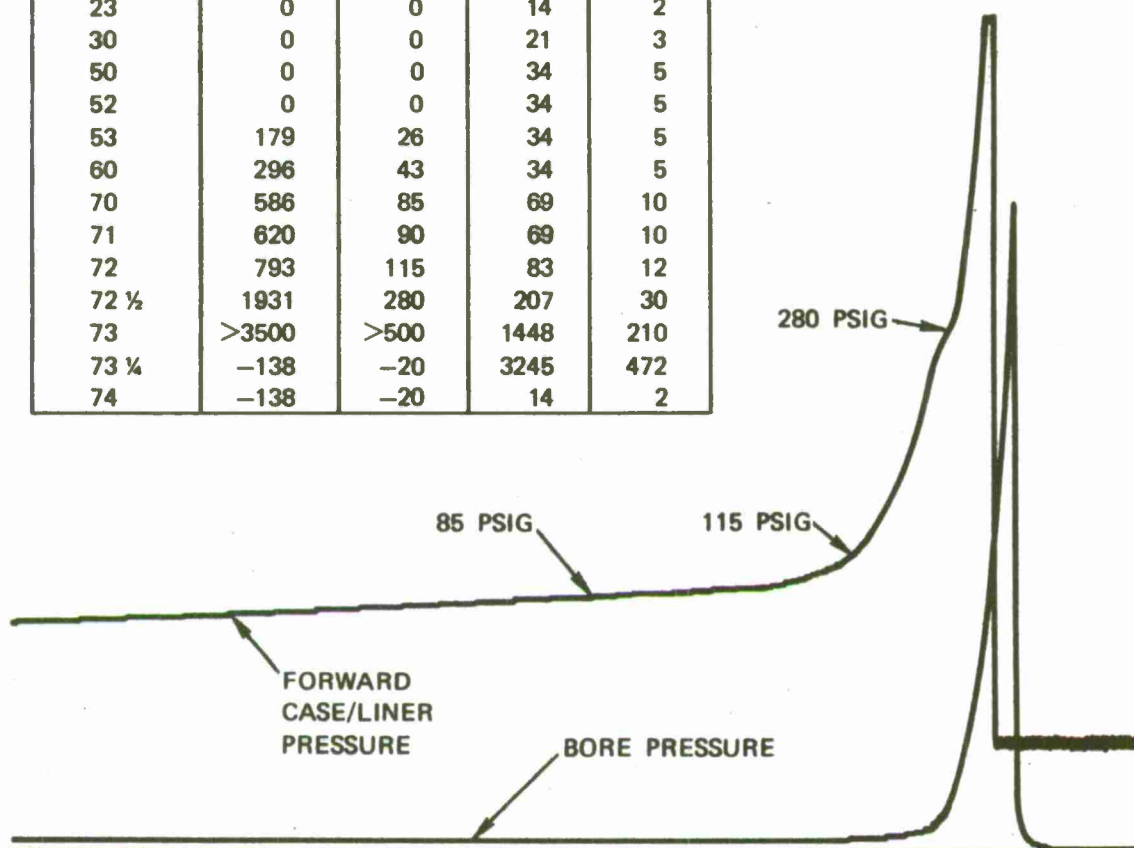
FIGURE 37. Pressure Measurements Near Reaction of Dual-Liner Model Motor Cook-Off Test.

As can be seen in Figure 35, the case/liner pressure tap location was changed to the forward instead of the midbottom location as previously done. Figure 37 presents the pressure data, which follow the typical pattern of case/liner pressure rising quite rapidly just prior to rupture and bore peak pressure occurring just after "rupture."

TIME, SECONDS	FORWARD CASE/LINER PRESSURE		BORE PRESSURE	
	kPa	PSIG	kPa	PSIG
20	0	0	0	0
23	0	0	14	2
30	0	0	21	3
50	0	0	34	5
52	0	0	34	5
53	179	26	34	5
60	296	43	34	5
70	586	85	69	10
71	620	90	69	10
72	793	115	83	12
72 ½	1931	280	207	30
73	>3500	>500	1448	210
73 ¼	-138	-20	3245	472
74	-138	-20	14	2

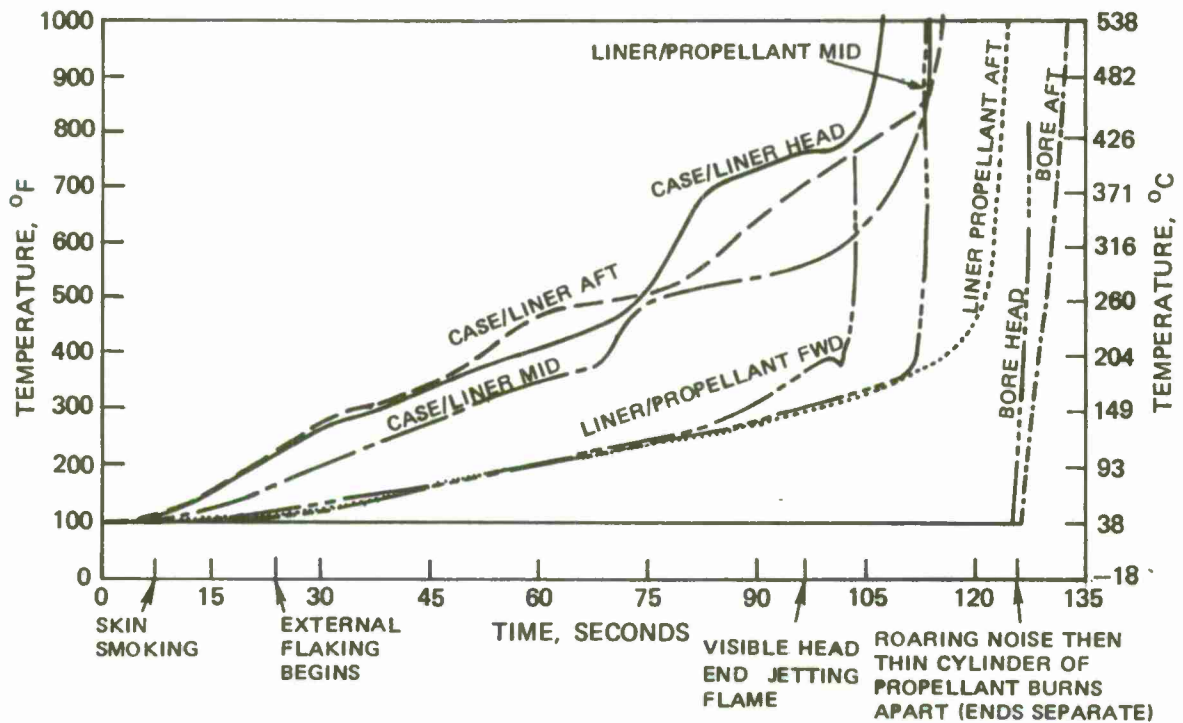
FIGURE 39. Temperatures During Cook-Off.

Figure 39 depicts the thermocouple data and indicates the visible activities (marked at times of occurrence). The first visible flame did not emanate from the bottom of the test item. It occurred at 93 seconds and the forward liner/propellant thermocouple was the first to indicate flame (fast rise to saturation) at 103 seconds.

This plastic reinforced construction gave very satisfactory results—mild burning.

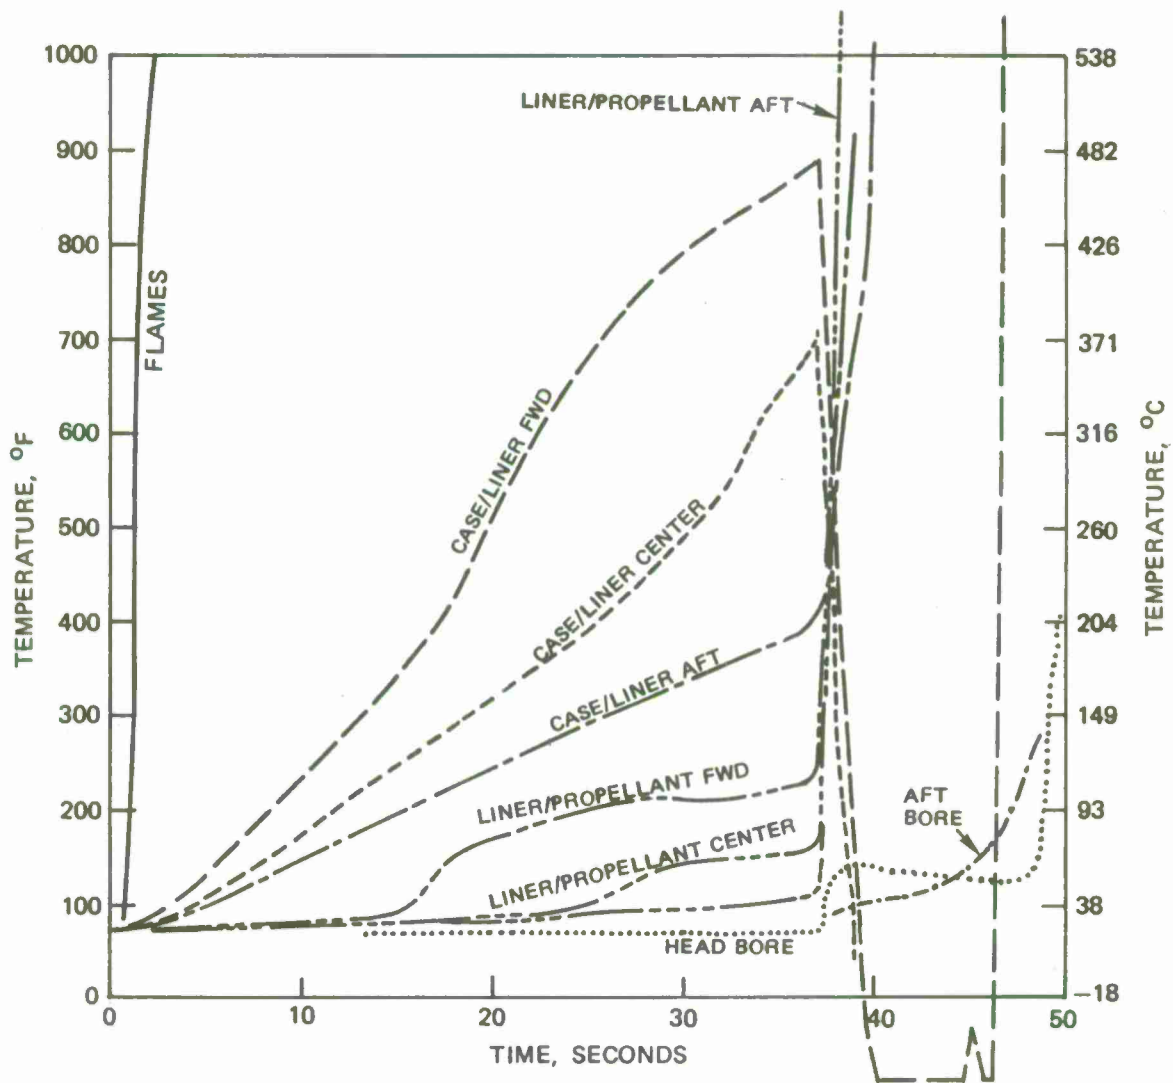
FIGURE 40. Temperatures During Cook-Off of NPCL-13 Model Motor.

A second test using nitroplasticized polycaprolactone (NPCL) binder propellant in the extended model motor hardware was conducted. The smokeless NPCL-13-7557 propellant was cast onto LR-29 liner with this liner having an undercoat of polyether polyurethane liner. Cook-off over the propane burners facility resulted in case rupture occurring at 37 seconds. This exactly duplicated the previous test with this type of propellant. The thermocouple data (Figure 40) show the bottom forward test section case ID temperature to be 478°C (893°F) at reaction time with center and aft temperatures being much lower, which is somewhat atypical. Maximum liner/propellant temperature was 109°C (229°F) (at the forward end of the test section). The aft bore temperature jumped at reaction time (37.4 seconds) but then continued to drift upward to about 51.5 seconds when rapid rise started. The forward bore temperature also jumped at 37.4 seconds, but then drifted downward (cooled) until 48.7 seconds when rapid rise (flame) was indicated. This probably means gas leaked into the bore at the aft seal, which correlates with the abnormal, soft liner observed before assembly. The reaction occurred early and, again, this must correspond to the lower thermal stability of the propellant. The case temperature was lower; thus, the pressure required to rupture the case was higher.

The high speed movie showed slight grain slippage from the aft end at rupture. Grain deformation "at" rupture of the case was extreme—sort of resembled an inchworm. A small area on the bottom started burning about one second after rupture and spread slowly. The head end, with much propellant still unburned therein, fell off about 20 seconds after rupture. Whistling started at 50 seconds, corresponding to the bore ignition (thermocouple data), and was due to acoustic resonance driven by combustion energy.
